Manhole Inspection Summary

Manhole # S37I__037MH

Insp Date: **8/19/08 10:45 AM**

Location Address: **rear 500 e pratt st**

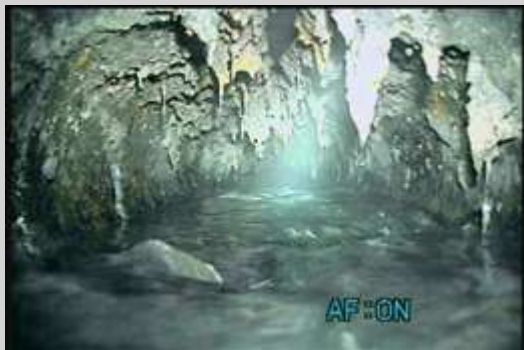
12 O'Clock Outflow

15 in. Circular Gravity Sewer
Pipe Out @ 12 O'Clock

Pipe Material: **Clay** ☐ Pipe Lined

Deposits: ☒ None ☐ Mud ☐ Sludge ☐ Debris ☐ Grease

Infiltration: **None** Pipe Seal Cond: **Unknown**

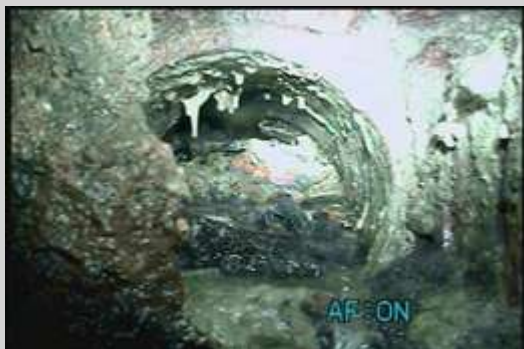
3 O'Clock Inflow

8 in. Circular Gravity Sewer
Pipe In @ 3 O'Clock

Pipe Material: **Clay** ☐ Pipe Lined

Deposits: ☒ None ☐ Mud ☐ Sludge ☐ Debris ☐ Grease

Infiltration: **None** Pipe Seal Cond: **Unknown**

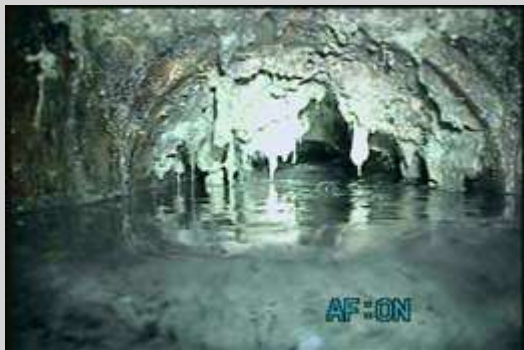
9 O'Clock Inflow

8 in. Circular Gravity Sewer
Pipe In @ 6 O'Clock

Pipe Material: **Clay** ☐ Pipe Lined

Infiltration: **None** Pipe Seal Cond: **Unknown**
